## Keystone RV Company

## **Outback Loft Trouble Shooting Guide**

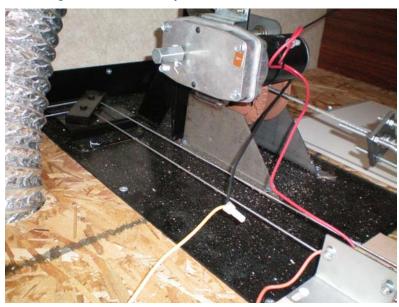
Fig. 1

**ISSUE**; MOTOR MOUNTING PLATE

**Symptom;** The roof does not raise or lower, lift system motor makes a faster than normal ratcheting noise.

**Cause**; The winch gearbox clutch is slipping.

**Inspection**; Run the motor while watching the winch to verify the winch is turning.

**Correction**; Replace the motor/gearbox assembly

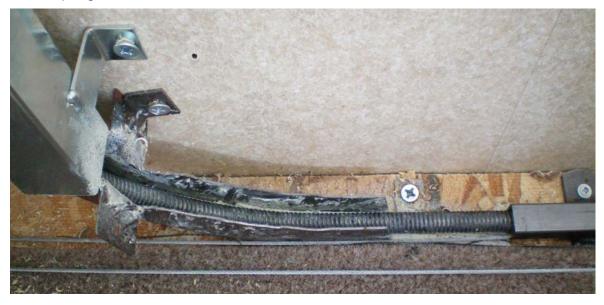
Fig. 2

ISSUE; FLOOR TRACK CABLE ALIGNMENT

Symptom; Frayed or broken cable, cable misaligned.

Crossed cables, misaligned cable in floor track. Cause;

**Correction**; Orient the cable so it enters the floor track tube in the correct corner. Support the roof to relieve

the spring tension, remove the floor track to access the cable.

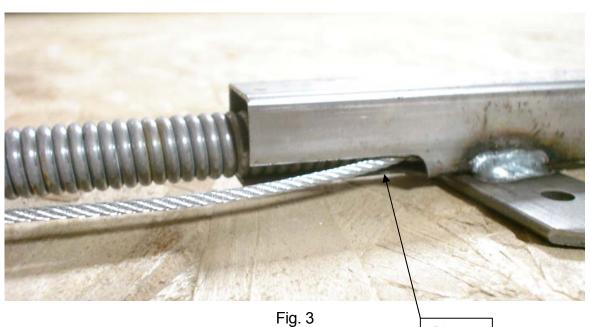
**CABLE** NOTCH Keystone RV Page 3 of 4

Inspection; Verify the cable notch is on the bottom inside corner of the track tube. Cable must enter the

floor track thru the notched corner of the tube (figure 3).

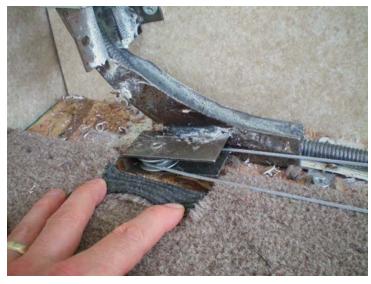
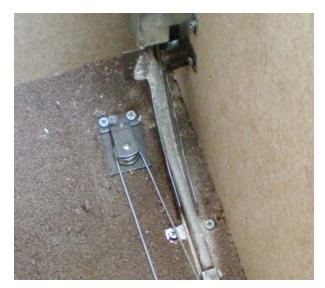
Fig. 4 Fig. 5

ISSUE; REAR PULLEY BRACKET

**Symptom;** Cable rubs on pulley bracket

Cause; Pulley misalignment

**Inspection**; Visually inspect the cable in pulley to verify it is seated completely in the pulley

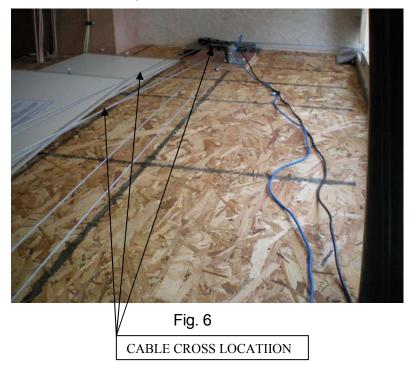
ISSUE; CROSSED CABLES

**Symptom;** Frayed or broken cables.

Cause; Crossed cables

**Inspection**; Verify the cables running from side to side do not cross and contact each other

**Correction**; Reroute cables to maintain separation
