Fixing stop pin for the backrest

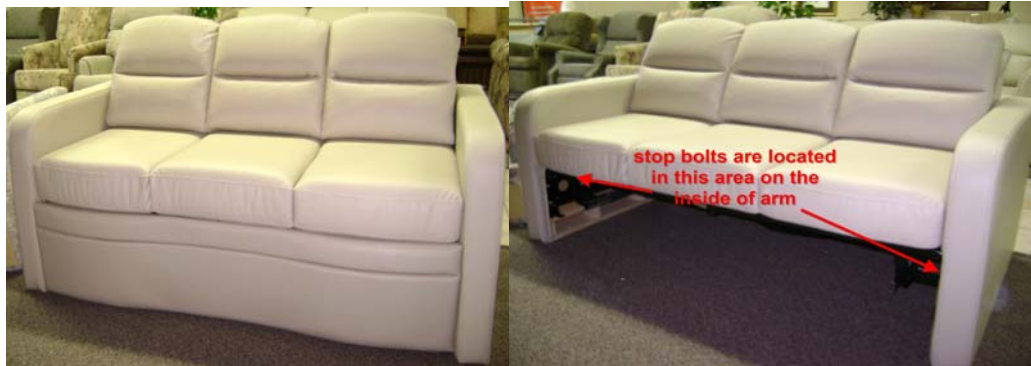
Remove drawer with kickboard. (To remove drawer, release sidetracks by picking up and pushing down the slide track releases; then, remove drawer from under seat of the sofa.)

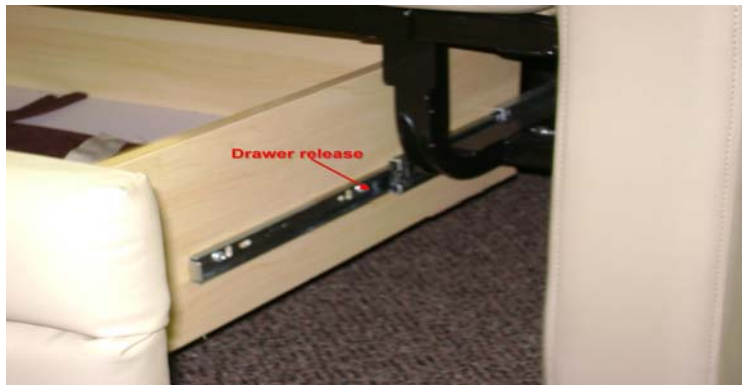
After drawer is removed, make sure the sofa is un-secured from the floor (& wall?) and the slide sofa is pulled out from the wall. Tilt sofa onto the front face of the armrest. (Remember the backrest will want to rotate forward when tilting sofa on front face of armrest- so hold onto the backrest and lower it to the floor).

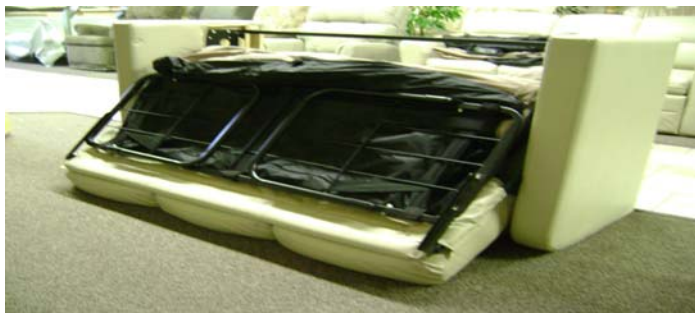
Now, **if the sofa has wooden bun and cylinder feet**, remove them with 1/2" socket and 3" extension.

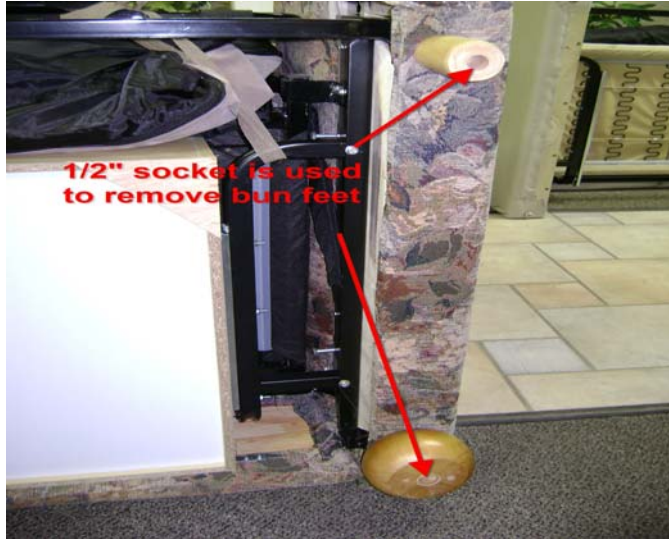
Then, **for all sofas**, remove the 10 silver Phillips screws, and the arm should slide outward and off the metal structure.

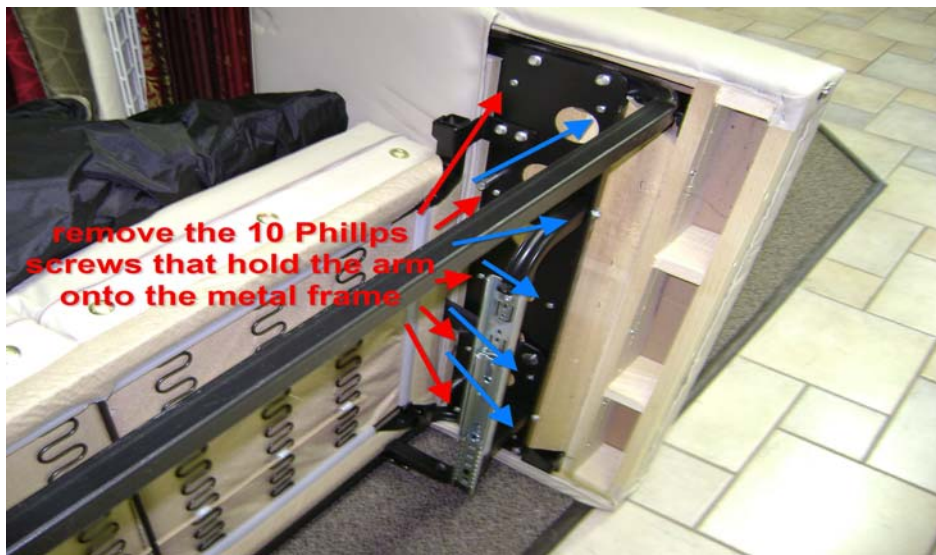
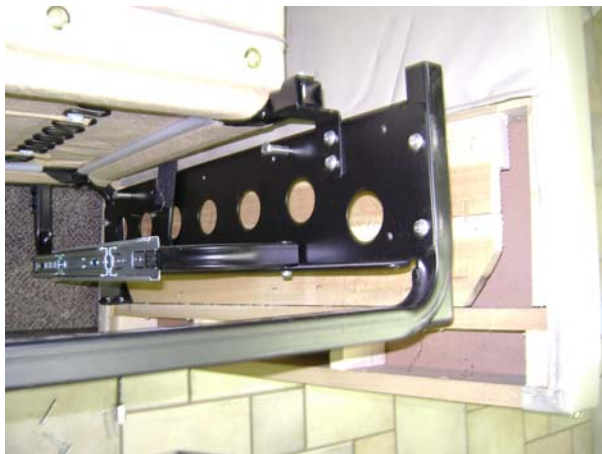
Using the pliers or ½” box end wrench, take apart the welded T-nut that has broken off and keep the bolt.

Now, take one nut and thread it onto the bolt; then put a washer on the bolt. Reinstall the bolt back into the hole and put another washer on the bolt, then a 2nd nut.

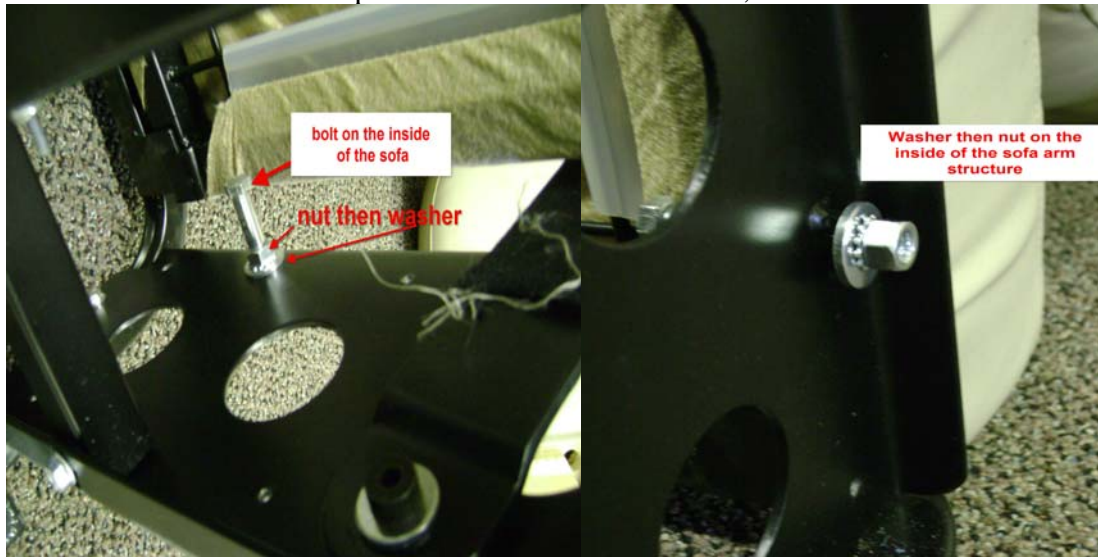
Make sure that the bolt is tighten firmly and is straight.

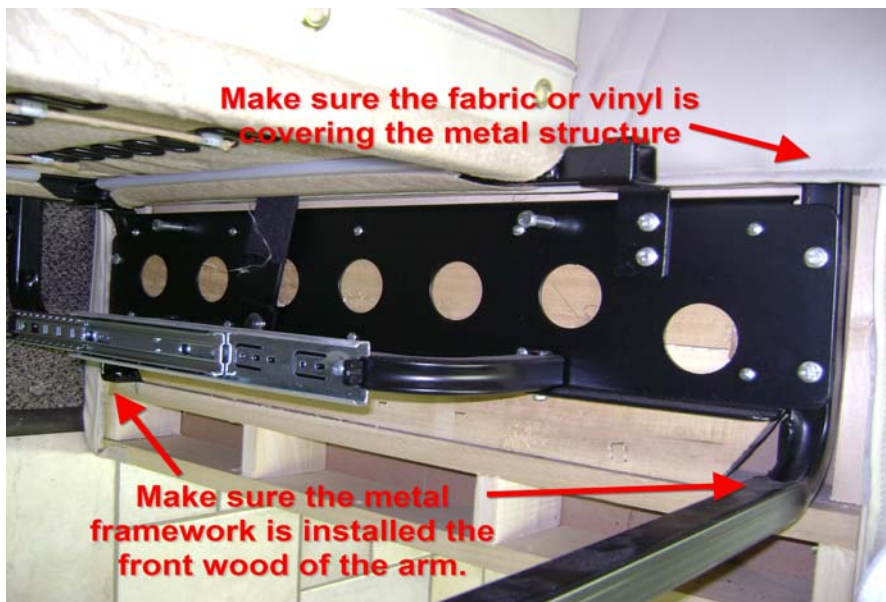
Before, **reinstalling the arm of the sofa onto the metal structure**, make sure the fabric or vinyl is covering the structure at the rear top corner of the metal structure. Then, as you are reinstalling the arm, make sure the metal framework is installed against the front wood of the armrest. Reverse your steps and make sure sofa is re-secured to the floor (& wall?) of the RV.
