****Service Bulletin****

Black Tank Flushing System

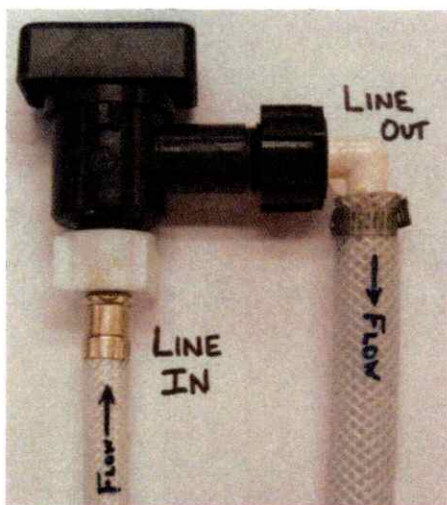
IMAGE #1

The 571 Vac Chk must be installed with the water flow in the proper direction and orientated in an upright position with cap on top. (See Image #1)

CORRECT

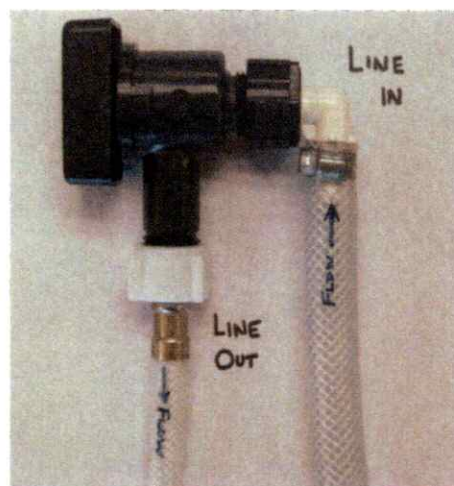
IMAGE #2

If the 571 Vac Chk is in an incorrect position after installation or replacement, it will not work as designed and leakage will likely occur. (Image # 2)

INCORRECT

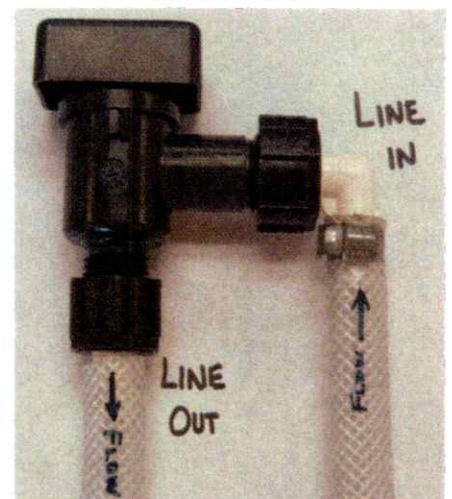
IMAGE #3

Plumbing lines connected in reverse, (Image # 3), will not allow water flow thru the 571 Vac Chk without causing potential damage.

INCORRECT
